# **A CRITICAL REVIEW OF BEACH RESTORATIONS PROJECTS IN THE NORTHERN COAST OF CADIZ (SPAIN) AFTER THIRTEEN YEARS**

The main purpose of this paper is to present a critical review of different beach restoration projects conducted since 1992 till today at the northern coast of Cadiz (Chipiona and Rota counties) by analyzing the different coastal engineering and coastal management considerations used in their design. In particular, four different cases of beach nourishment projects are analyzed, having each one specific and interesting points to be stressed : a) Regla beach nourishment project ; b) Rota beach nourishment project; c) Punta Candor dune restoration project ; and d) La Ballena nourishment project.

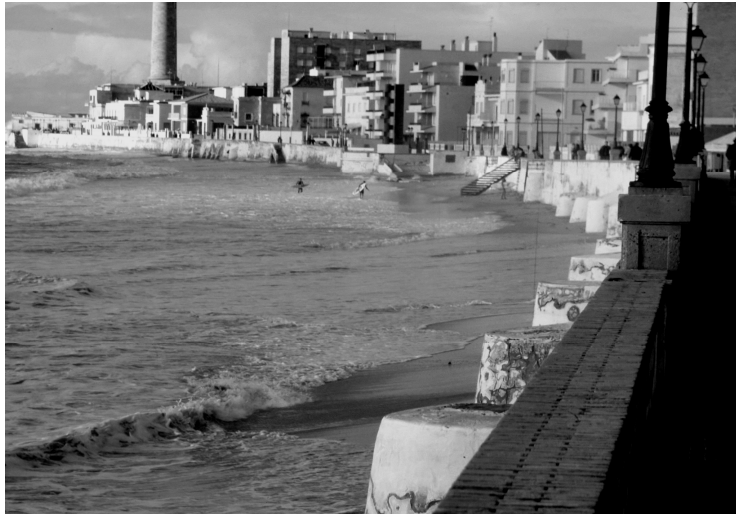
Figure. 3. Northern view of Regla beach (Chipiona Co.) at high tide in 1991, prior to beach restoration (Source: Gómez-Pina's photograph collection,).

Figures 3 and 4, taken by Gómez-Pina in 1991, show an almost non-existent dry beach at daily high tide.

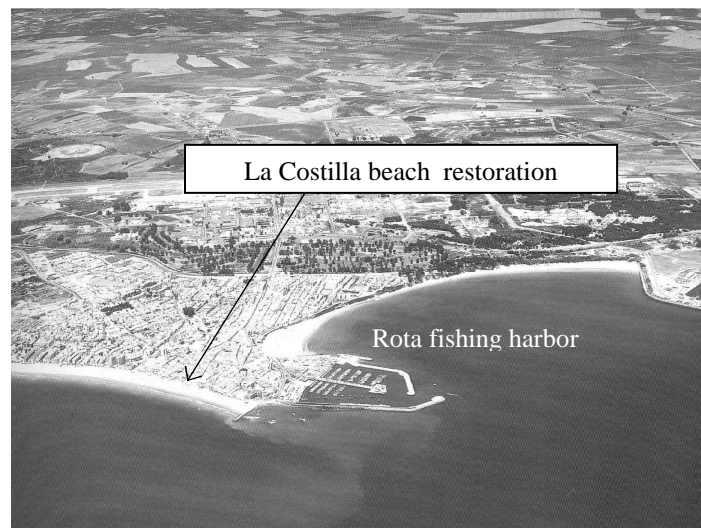
**Figure. 7.** Aerial view of the southern part of La Costilla beach restoration project, Rota Co. (Source: Spanish National Coastal Authority)

Fig. 7 depicts an aerial view of La Costilla beach restoration project. Fig. 8 is a detail of the beach and waterfront integration.

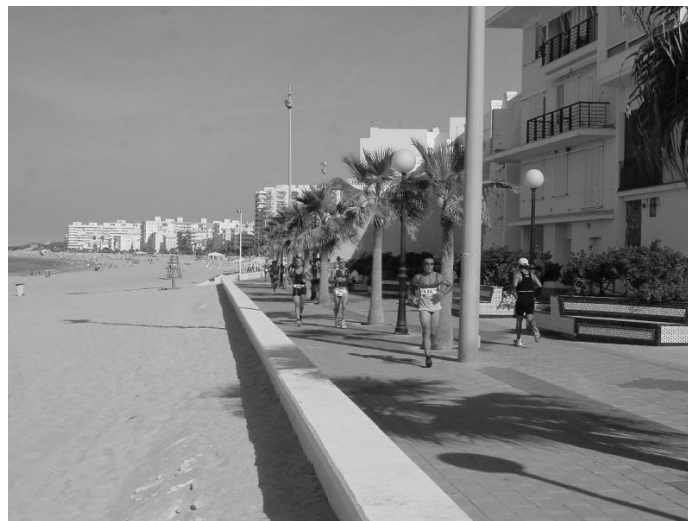
**Figure.8** A good example of beach and waterfront integration in La Costilla beach, Rota Co. (Source: Gómez-Pina's photograph collection).
